PEMBROKE C. MK.1 WV.699

RADIO ACCEPTANCE TRIALS

8th Part of Report No. AAEE/896

23 FEB 1954

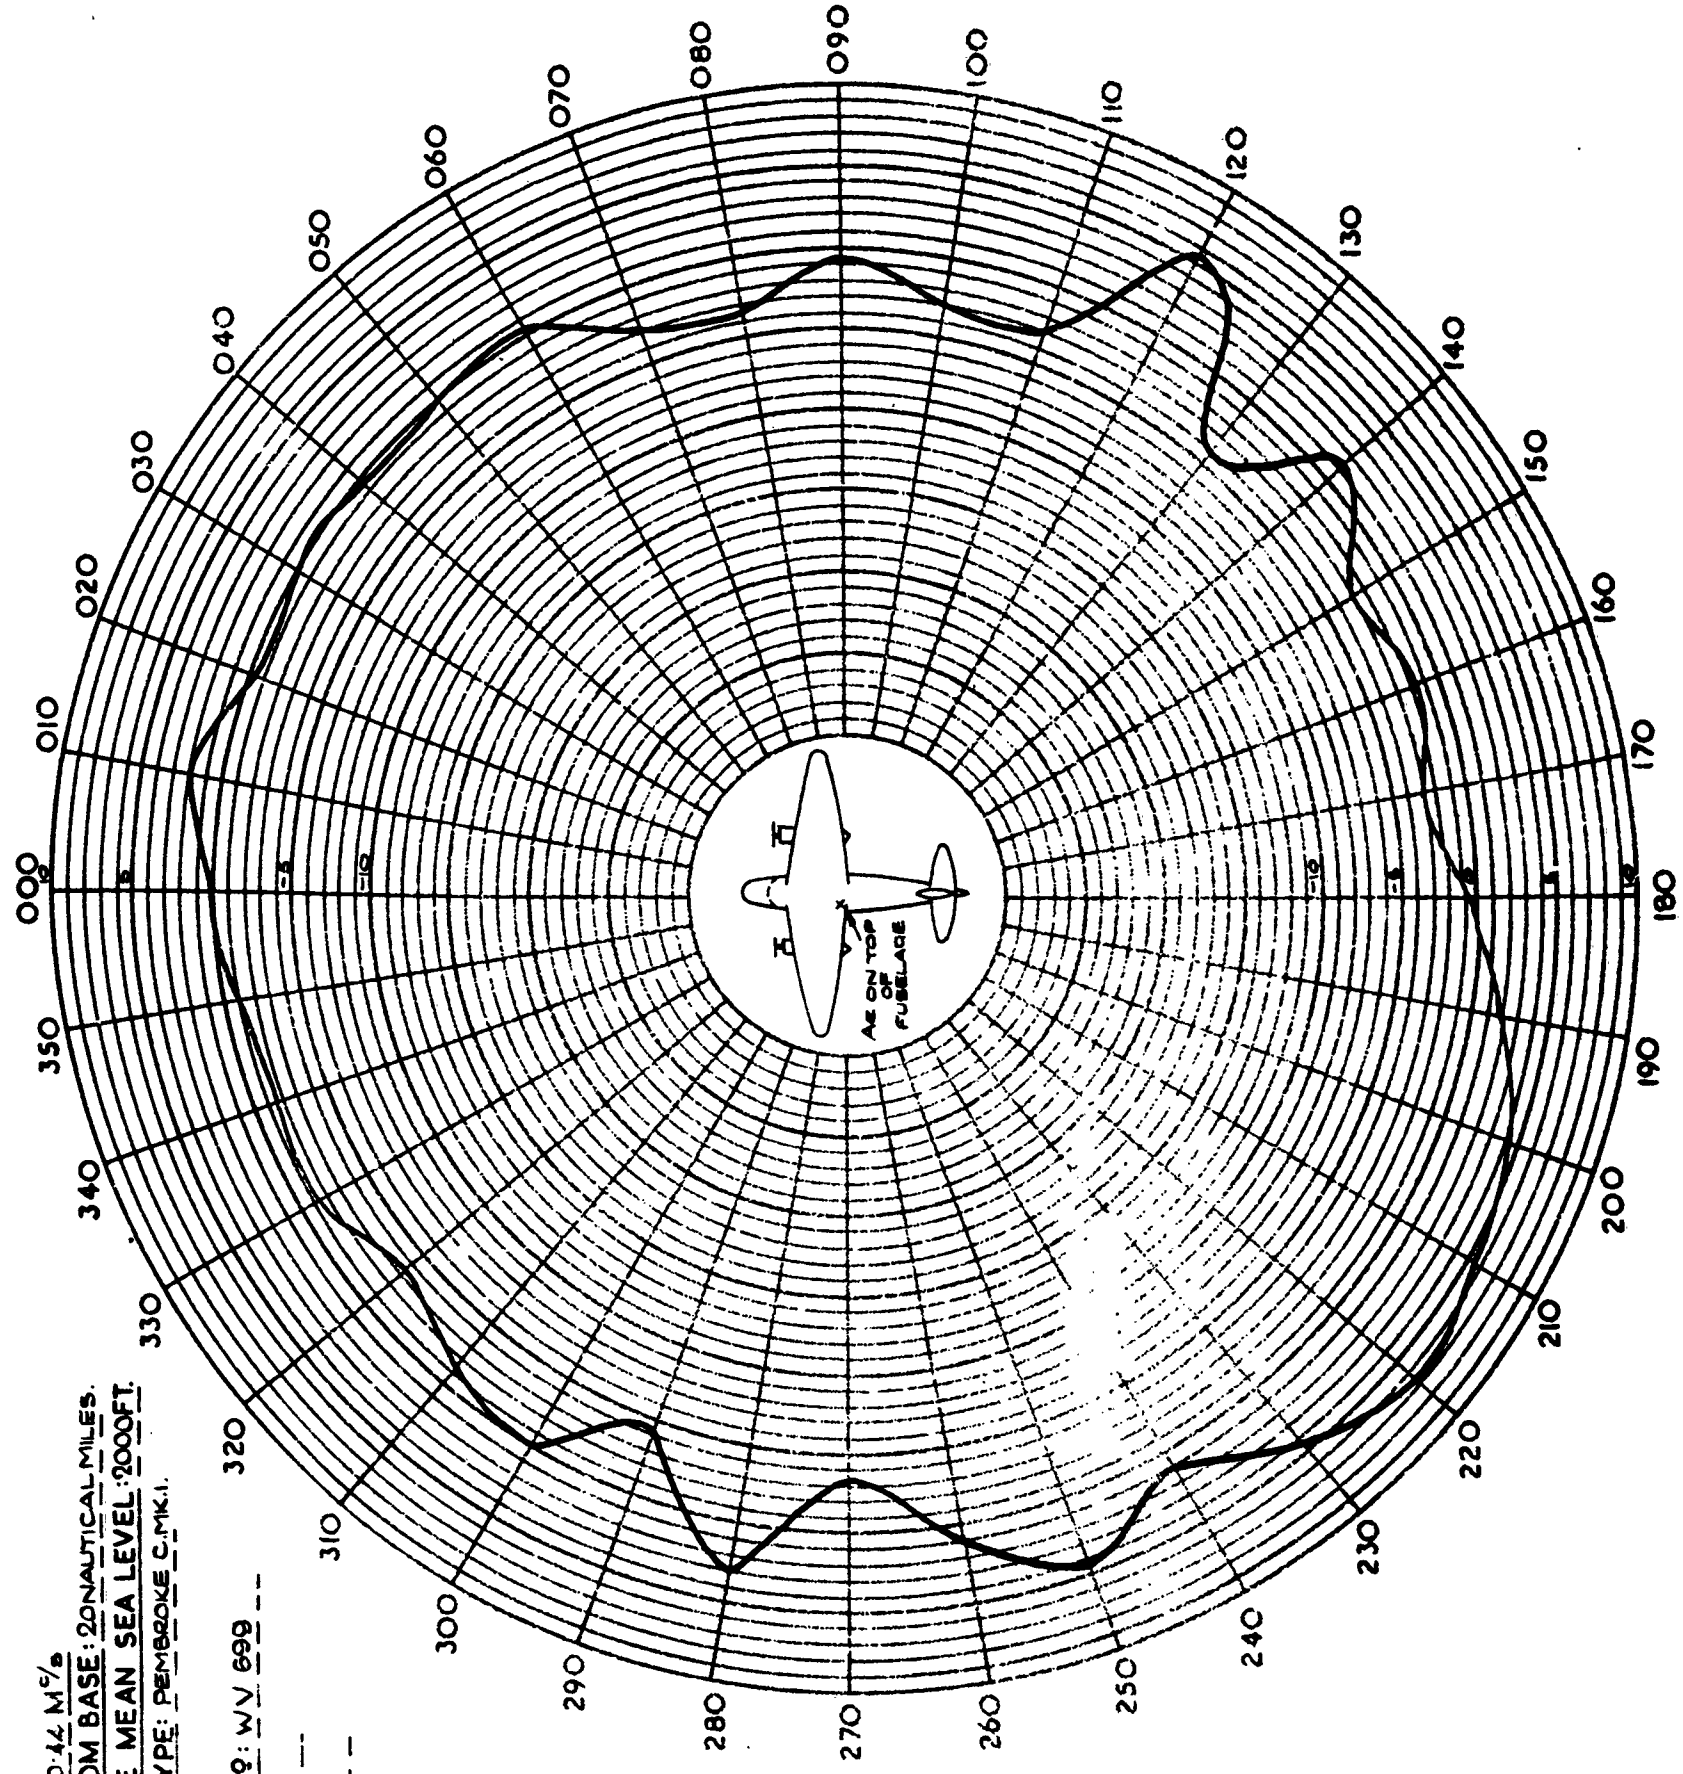
FIG.12.

4.3.1. Polar diagrams. The results of the polar diagram runs are given in Figs. 12 and 13 and are satisfactory.
